Manhole Inspection Summary

Manhole # S21K__048MH

Location Address: **1933 s payson-goldsmith alley**

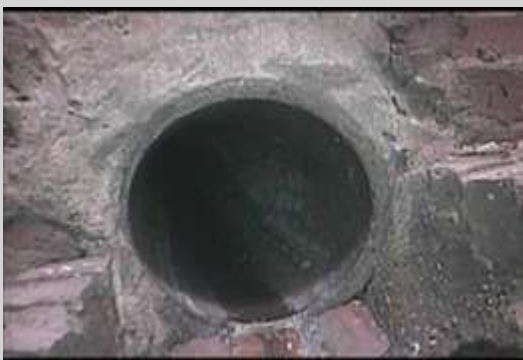
3 O'Clock Inflow

8 in. Circular Gravity Sewer
Pipe In @ 3 O'Clock

Pipe Height: **8.4** (in.) Rod and Bar (Angled)
Pipe Material: **Clay** ☐ Pipe Lined
Invert Depth: **7.75** (ft.) Flow Characteristics: **Slow**
Deposits: ☒ None ☐ Mud ☐ ~~Gravy~~ ☐ Debris ☐ Grease
Silt Depth: **0** (in.) Deposits Extent:
Infiltration: **None** Pipe Seal Cond: **Sound**
